Manhole Inspection Summary

Manhole # S13G1_008MH

Insp Date: **3/7/08 1:36 PM**

Location Address: **3200 S Caton AV**

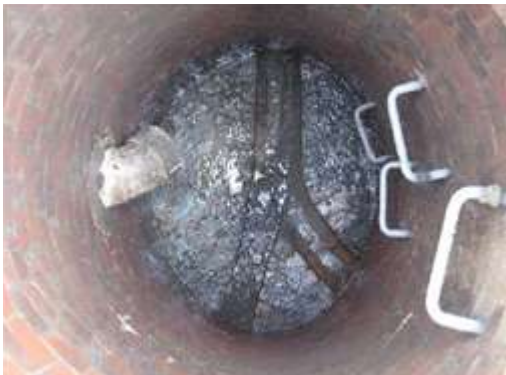
misc

bench debris

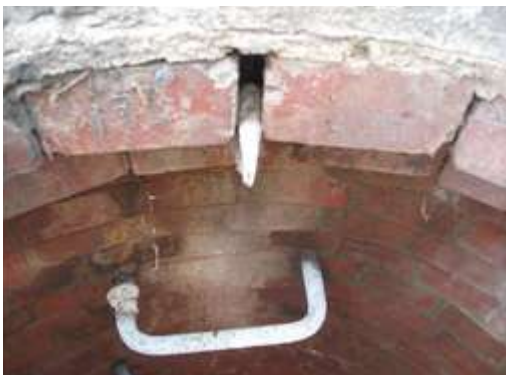
Defect 3

missing mortar

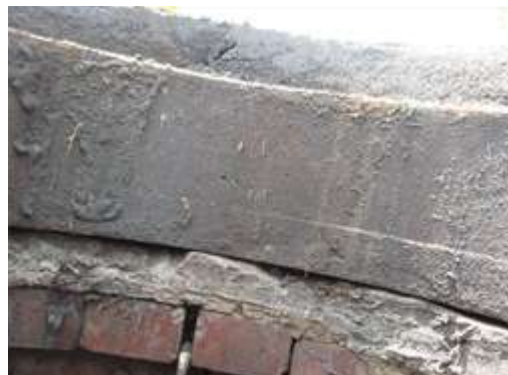
Defect 2

Infiltration: ☐ None ☒ **Joint** ☐ Cracks ☒ **Mortar** ☐ Roots ☐ Wall

missing mortar signs of infiltration from chimney-frame connect

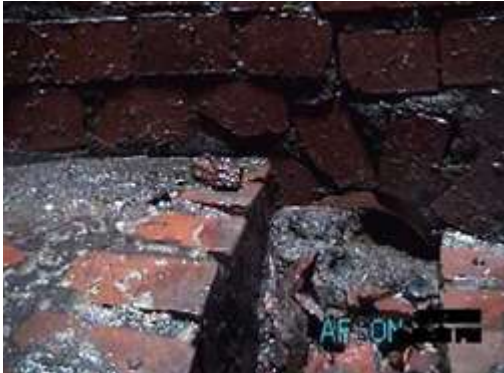
Defect 4

Condition: ☐ Sound ☐ Cracked ☐ Root Intrusion ☐ Deteriorated ☐ Leaks ☒ **Debris**

channel cond debris

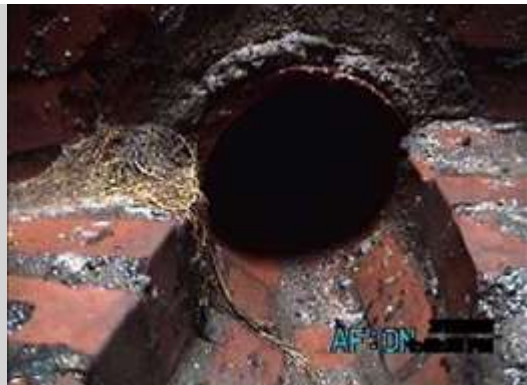
4 O'Clock Inflow

Infiltration: ☐ None ☐ Joint ☐ Cracks ☐ Mortar ☒ **Roots** ☐ Wall

fibrous roots infiltrating on barrel

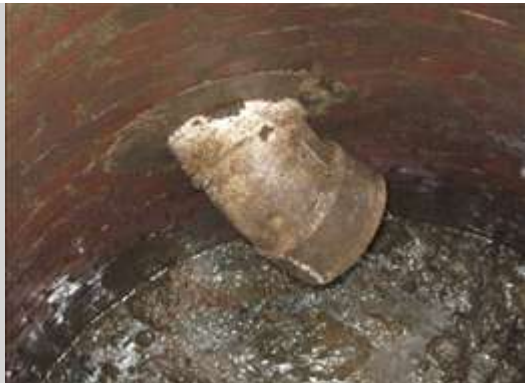
8 O'Clock Inflow

service pipe unable to measure
